LINNTON PLYWOOD ASSOCIATION – TECHNICAL EVALUATION

Upland Site: Linnton Plywood Association
10504 NW Saint Helens Road (Fig. 1)
26.5 Acres
RM 4.4 to 4.8

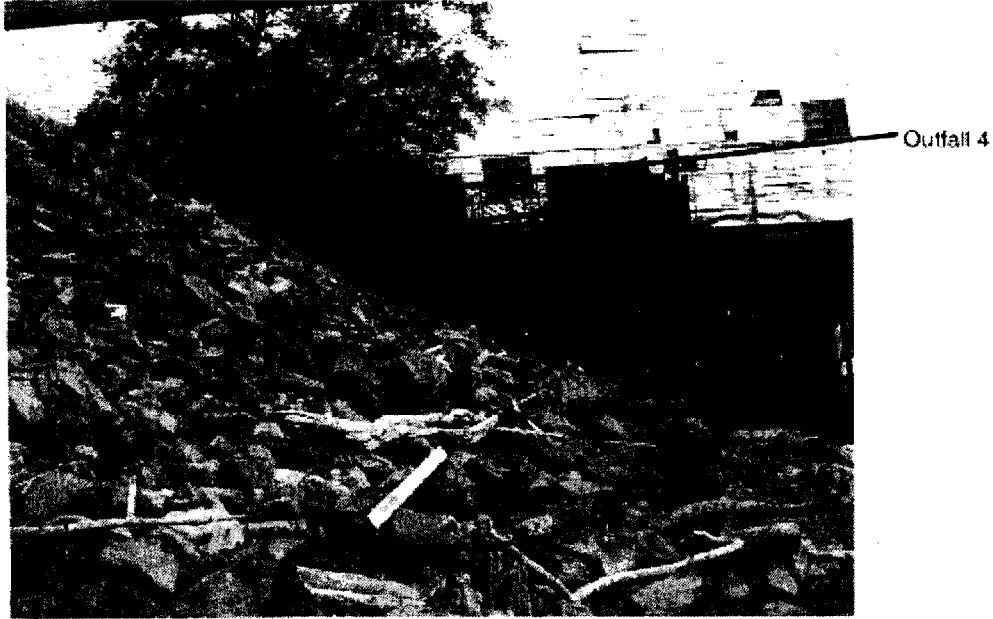
Outfall 4: Outfall 4 is located 30 feet downstream of outfall 3. This outfall drains storm water from the roofs of the plywood mill. The outfall discharges approximately 10 feet below the paved area grade onto a riprap slope above the 17 feet MSL facility boundary. This outfall was not sampled.

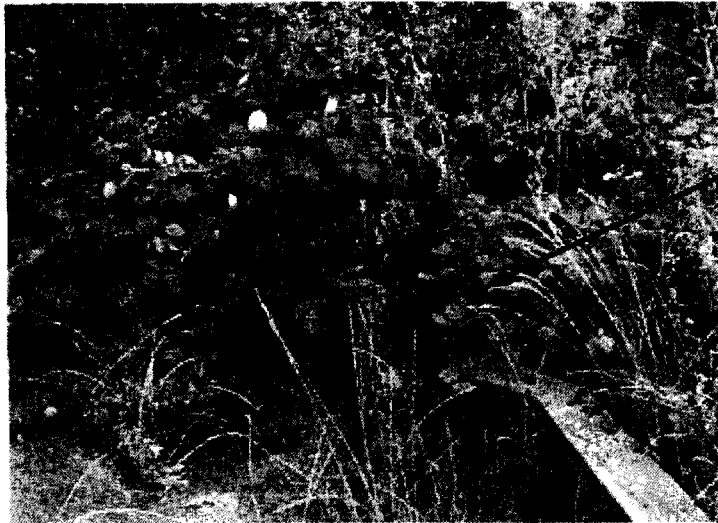
Outfall 2: The drainage basin for this outfall is the paved area on the southeast side of the plywood mill. The outfall discharges approximately 2 feet below the paved area grade onto a riprap slope above the 17 feet MSL facility boundary. Land area where sander dust ash has been placed may also drain to this outfall. Sampling shows that the following chemicals exceed screening levels for this outfall: Phenol and pentachlorophenol detection limits were too high (40-60 times SLVs) to determine whether these parameters were of concern. Sampling shows that none of the chemicals analyzed exceed screening levels for this outfall. Benzo(a)pyrene, phenol and pentachlorophenol detection limits were too high (40-60 times SLVs) to determine whether these parameters were of concern.

Catch basin
discharge on outhur
side of curb.
